**Flood Control Project Maintenance  
Levee Inspections**  
**LMA District Cover Sheet**  
**Spring 2019 Levee Inspection Results**

**Reclamation District No. 0563 Tyler Island**

**Spring 2019 Levee Inspection Results**

Waterway			Bank	Unit Miles
Unit No. 01 Georgiana Slough (Tyler Island)			Left	12.11
	Spring (March - May)	Summer (June - August)	(September - November) Fall	Winter (December - February)
Unit Maintenance Rating (Fall Only)				
Date of Inspection	4/5/2019 - 4/5/2019			
DWR Inspector	David Julian			
Accompanied By	Steve Mello RD 563

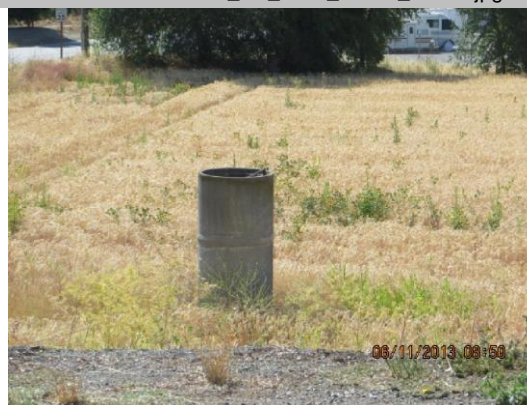
Photo 1 of 3 : UCIP\_SP\_2019\_52739\_24503.jpg

Comment Code					
Inspector Comment					
FS_ID:52739					
DS_ID:20199					
EP_NO: N/A					
Repair Type: Non-Urgent					
Crossing Status: Indicator Found					
UCIP Comments: 07/13/2018 Unable to locate the pipe. Only standpipe found on LS. (O.Yakimov-DWR UCIP)6/11/2013 Need to determine disposition of pipe. Was it abandoned properly?					
FIELD_STRUCT_DESC: 10-inch steel irrigation pipe through the levee, at an unknown depth. 36-inch concrete standpipe at the landside (LS) toe. Unable to locate pipe, 06/11/2013. [Additional Reference(s): USACE Sacramento O&M Manual 103, June 1954, (Station ""L"" 6+39), listed as a 1-inch pipe and a 36-inch pipe].					
FS Date: 7/13/2018 9:06:44 AM

36-inch concrete standpipe on LS toe.

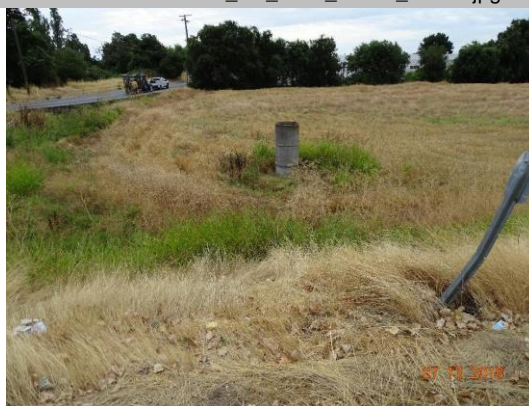
Photo 2 of 3 : UCIP\_SP\_2019\_52739\_77710.jpg

Standpipe located on LS.

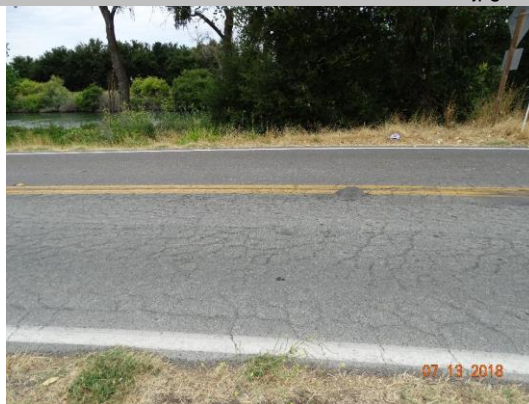
Photo 3 of 3 : UCIP\_SP\_2019\_52739\_77711.jpg

View of levee crown at the crossing.

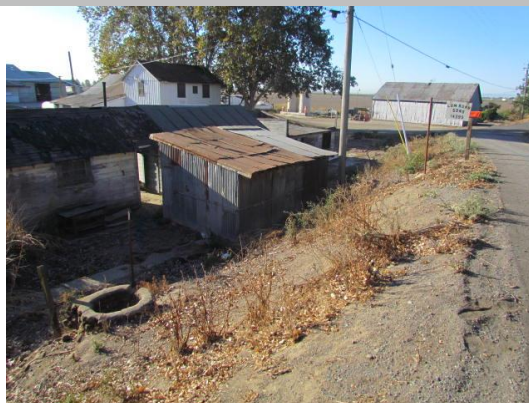
Photo 3 of 3 : SP\_2019\_RD0563\_210\_10\_20190311\_00008.jpg

Looking southeast at storage shed at landward toe.

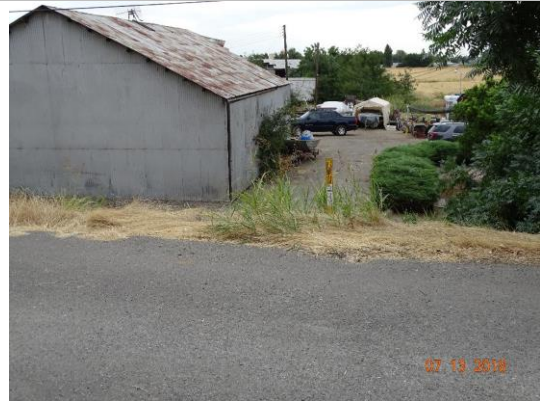
Photo 3 of 3 : UCIP\_SP\_2019\_52740\_77712.jpg

Sign on LS slope.

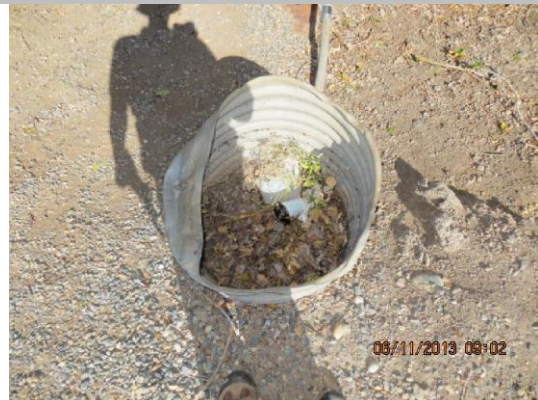
Photo 2 of 3 : UCIP\_SP\_2019\_52741\_24507.jpg

Comment Code						
Inspector Comment						
FS_ID:52741 DS_ID:20130 EP_NO: 11218 Repair Type: Non-Urgent Crossing Status: Found UCIP Comments: 07/13/2018 Electrical conduit that is attached to the pipe on WS fell appart at several locations. LS and WS slopes are heavily vegetated. (O.Yakimov-DWR UCIP)06/11/2013 Pipe leaking at various points on WS berm. Failure on berm may indicate potential for failure within the levee. Good candidate for video inspection. (W.Wylie-DWR) FIELD_STRUCT_DESC: 12-inch steel irrigation pipe through the levee, 5 feet below the crown. Walkway to pump on pile structure in stream. Siphon breaker in a 24-inch corrugated metal pipe (CMP) riser on the waterside (WS) shoulder. 1-inch air and vacuum valve and a 15-foot-tall by 36-inch-diameter concrete standpipe at the landside (LS) toe. (Automatic Board Order (ABO) issued as Permit No. 11218, 1975 - Fong Yock Yee). [Additional Reference(s): DWR Levee Log, 2005. USACE Sacramento O&M Manual 103, June 1954, (Station ""L2"" 196+67.8)]. FS Date: 7/13/2018 9:38:39 AM

Siphon breaker not visible in 24-inch CMP riser on WS shoulder.

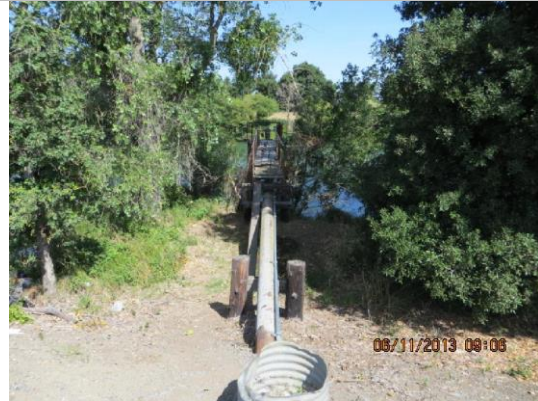
Photo 3 of 3 : UCIP\_SP\_2019\_52741\_24509.jpg

Pipe and pier on WS.

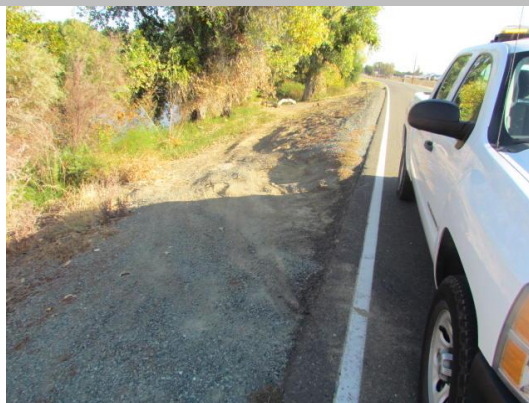
Photo 1 of 1 : SP\_2019\_RD0563\_210\_34\_20190311\_00017.jpg

LM Start	0.53	Rating **	M	Issue No.	34
LM End	0.53	Issue Type +	Ma	Location *	WS
Category	Earthen Levee			GPS Latitude/Longitude	
				Start	End
Item	Slope Stability			38.229232 °	38.229232 °
				-121.523538 °	-121.523538 °
DWR ID	DWR_RD0563_01_f_2018_34				
Comment Code					
S3 : Repair the levee slope damaged by vehicle traffic and prevent access where possible.					
Inspector Comment					
Slope damage is due to vehicle traffic.

Looking northwest at slope damage caused by vehicle traffic.

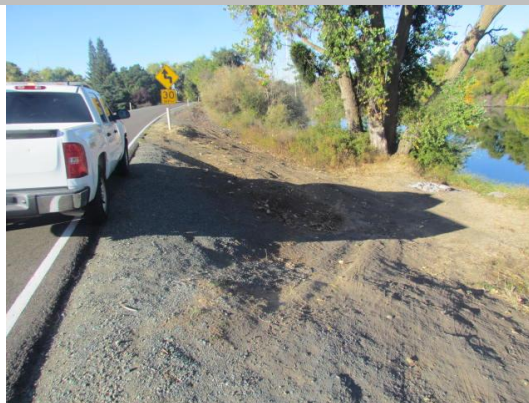
Photo 1 of 2 : SP\_2019\_RD0563\_210\_143\_20190311\_00104.jpg

LM Start	0.56	Rating **	M	Issue No.	143
LM End	0.56	Issue Type +	Ma	Location *	WS
Category	Earthen Levee			GPS Latitude/Longitude	
				Start	End
Item	Slope Stability			38.228930 °	38.228930 °
				-121.523935 °	-121.523935 °
DWR ID	DWR_RD0563_01_f_2014_143				
Comment Code					
S3 : Repair the levee slope damaged by vehicle traffic and prevent access where possible.					
Inspector Comment					
Slope damage is due to vehicle traffic.

Looking southeast at slope damage on waterward slope.

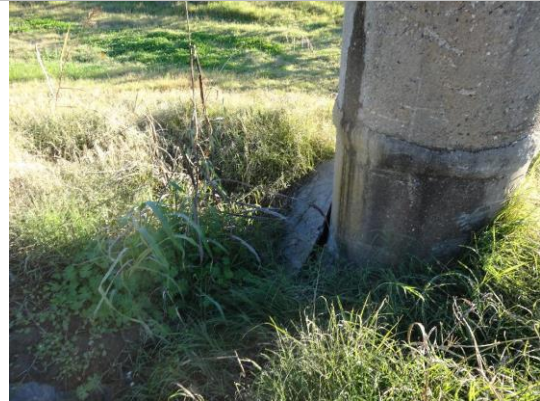
Photo 2 of 3 : UCIP\_SP\_2019\_52731\_76820.jpg

FS\_ID:52731  
DS\_ID:20131  
EP\_NO: 11203  
Repair Type: Urgent  
Crossing Status: Found  
UCIP Comments: 07/13/2018 Dense vegetation on LS slope limits visibility. Crossing remains "Urgent" due to unknown condition of the pipe section through the levee. (O. Yakimov-DWR UCIP)  
03/08/2018 LS pipe section replaced however, unable to determine the condition of the pipe section through the levee. LS levee section disburbed and has not been repaired. Crossing remains Urgent due to the unknown condition of the pipe section through the levee. (O. Magana - DWR UCIP)12/02/2016 Same as last inspection signs of leak are still present on both LS and WS. Recommend internal inspection of the pipe integrity through the levee to determine cause of depression on levee (either leak or poor compaction). Pipe debris previous noted on WS has been removed. (O. Magana - DWR UCIP)06/11/2013 Signs of leak in pipe at levee slope on both LS and WS where pipe enters levee. Moist soil at LS toe indicates possible internal leak. Evidence of recent pipe repair on WS. Pipe debris on WS toe should be removed. (W. Wylie - DWR UCIP)

Minor leaks visible on concrete standpipe.

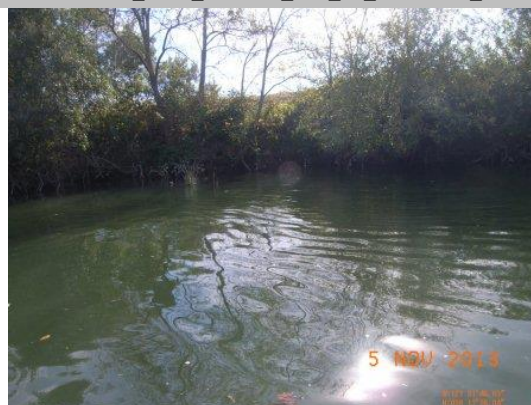
Photo 1 of 1 : SP\_2019\_RD0563\_210\_70\_20190311\_00029.jpg

LM Start	0.92	Rating **	M	Issue No.	70
LM End	1.11	Issue Type +	Ma	Location *	WS
Category	Supplemental			GPS Latitude/Longitude	
				Start	End
Item	2017 USACE Erosion Survey, DRAFT			38.225660 °	38.227157 °
				-121.527556 °	-121.530432 °
DWR ID	DWR_RD0563_01_f_2018_70				
Comment Code					
Inspector Comment					
2017 Site ID: GEO 11.0 L					
Status: Eroding					
2017 Field Notes: Increased toe erosion, slumping, boat wake erosion, and revetment failure near downstream end. Site extended upstream.					
Site History: 2011 - Short sections of eroding bank at the waterline and holes in toe of levee. 2012 - Site extended upstream. 2013 - Erosion pockets filled with an insufficient amounts of revetment. 2016 - Fresh erosion observed.

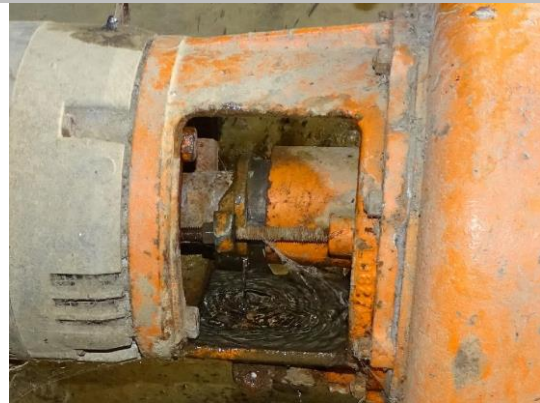
Photo 1 of 3 : UCIP\_SP\_2019\_52744\_77722.jpg

Comment Code					
Inspector Comment					
FS_ID:52744 DS_ID:20132 EP_NO: 11210 Repair Type: Non-Urgent Crossing Status: Found UCIP Comments: 07/13/2018 Water pump is running, leak thru pump seal is detected. Pipe on WS has been partially replaced with a new pipe to pumphouse. Remaining part of old pipe needs to be abandoned properly. (O.Yakimov-DWR UCIP)06/11/2013 Pipe does not have sufficient cover at crown. (W.Wylie) FIELD_STRUCT_DESC: 6-inch irrigation pipe of an unknown material through the levee, 3 inches below the crown. Pump and gate valve in pump house on the waterside (WS) slope. Service pole on the landside (LS) slope. (Automatic Board Order (ABO) issued as Permit No. 11210, 1975 - Leland O. Hanson). 1-inch polyvinyl chloride (PVC) electrical conduit through the levee at the same location, at an unknown depth. [Additional Reference(s): DWR Levee Log, 2005. USACE Sacramento O&M Manual 103, June 1954, (Station ""L"" 43+91.9), listed as a 14-inch pipe]. FS Date: 7/13/2018 1:28:34 PM

Water is leaking thru shaft sealing.

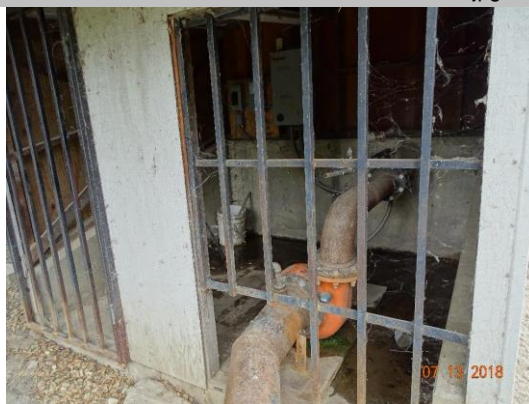
Photo 3 of 3 : UCIP\_SP\_2019\_52744\_77725.jpg

View of inside of pumphouse.

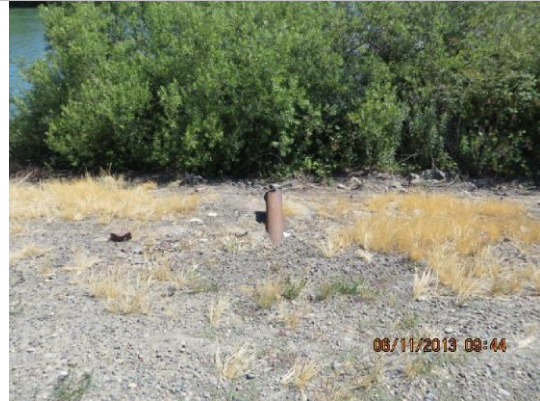
Photo 3 of 3 : UCIP\_SP\_2019\_52745\_24524.jpg

Comment Code						
Inspector Comment						
FS_ID:52745 DS_ID:20133 EP_NO: 11210 Repair Type: Non-Urgent Crossing Status: Found UCIP Comments: 07/13/2018 Pipe is open on LS. Same as last inspection. (O.Yakimov-DWR UCIP)12/02/2016 According to LMA representative, Darcy Neuderk, this crossing was installed in 1952 by the USACE and intended to be use for irrigation purposes. However, this crossing has never been used per LMA's knowledge. Crossing has been downgraded from "Urgent" to "Non-Urgent", the flap gate on the WS is functional and prevents any potential flood water from draining to LS. Recommend contacting property owner and working with the CVFPB to address abandoned crossing. (O. Magana - DWR UCIP)06/11/2013 Flap gate rusted in closed position. (W. Wylie - DWR UCIP) FIELD_STRUCT_DESC: 2 of 2: 8-inch steel drainage pipe through the levee, 3 feet below the crown. Flap gate on the waterside (WS). Pipe open on the landside (LS). (8-inch pipe [HLM 0.97] authorized under Automatic Board Order (ABO) issued as Permit No. 11210, 1975 - Leland O. Hanson). [Additional Reference(s): DWR Levee Log, 2005]. FS Date: 7/12/2018 1:40:12 PM

Pipe and flapgate on WS slope.

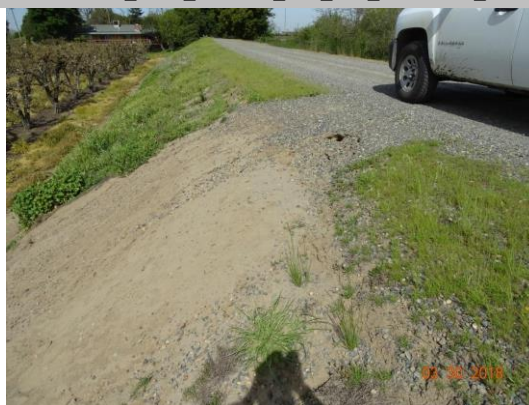
Photo 1 of 1 : SP\_2019\_RD0563\_210\_110\_20190311\_00077.jpg

LM Start	1.03	Rating **	U	Issue No.	110
LM End	1.03	Issue Type +	Ma	Location *	LS
Category	Earthen Levee			GPS Latitude/Longitude	
				Start	End
Item	Animal Control			38.226422 °	38.226422 °
				-121.529410 °	-121.529410 °
DWR ID	DWR_RD0563_01_s_2018_110				
Comment Code					
A3 : No rodents visible, but rodent burrows visible; need to backfill and compact or grout burrows.					
Inspector Comment					
A very large rodent burrow has caused the landside shoulder to collapse. The shoulder should be restored.

3/30/2018: Very large rodent burrow causing caving at landside shoulder.

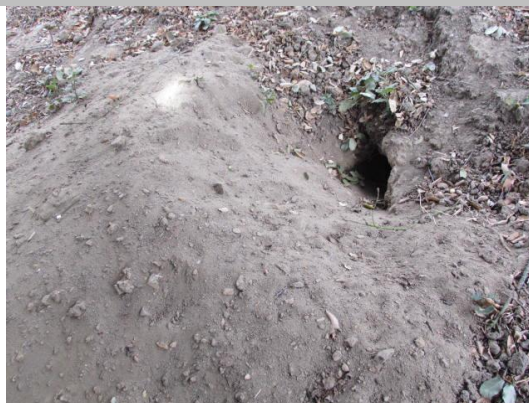
Photo 1 of 1 : SP\_2019\_RD0563\_210\_153\_20190311\_00113.jpg

Looking at typical view of several rodent holes on landward slope.

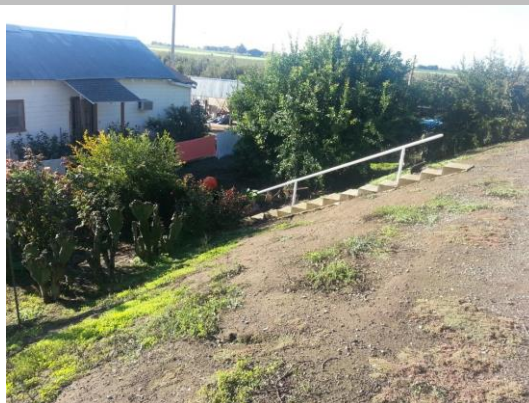
Photo 1 of 1 : SP\_2019\_RD0563\_210\_86\_20190311\_00056.jpg

Looking southwest at fruit trees and other plantings at landward toe.

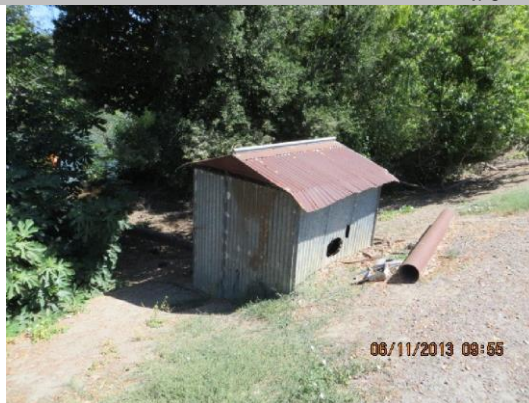
Photo 2 of 3 : UCIP\_SP\_2019\_52748\_24529.jpg

Pumphouse on WS slope.

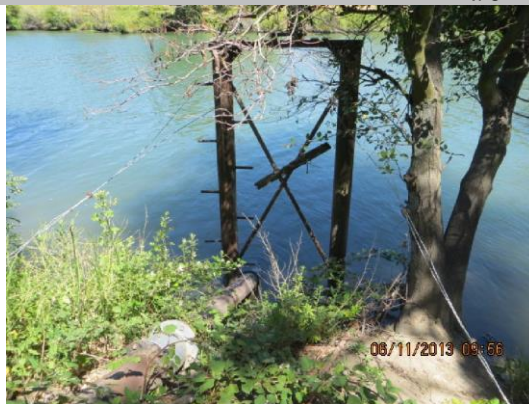
Photo 3 of 3 : UCIP\_SP\_2019\_52748\_24528.jpg

Pipe at WS toe.

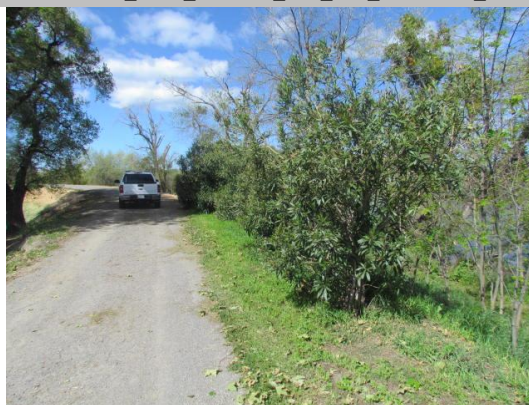
Photo 1 of 2 : SP\_2019\_RD0563\_210\_142\_20190311\_00100.jpg

Looking southwest at oleanders on waterward shoulder.

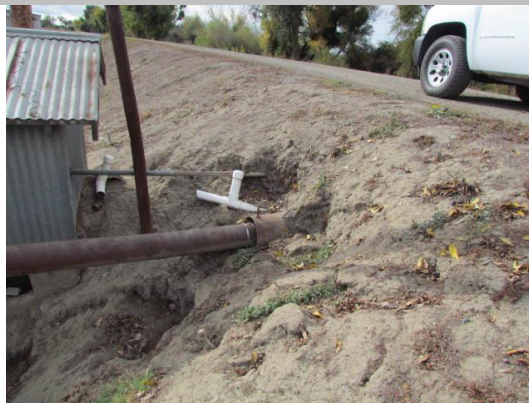
Photo 2 of 2 : SP\_2019\_RD0563\_210\_71\_20190311\_00031.jpg

Looking southwest at erosion around irrigation pipe on landside slope and toe.

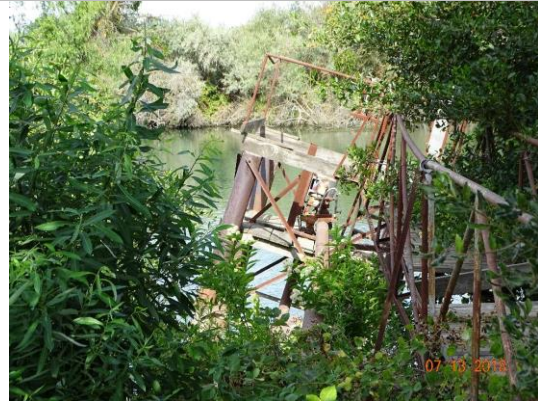
Photo 2 of 3 : UCIP\_SP\_2019\_52751\_77735.jpg

Tilted pump platform on WS.

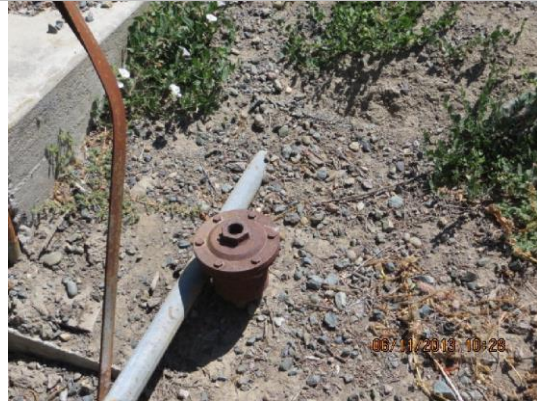
Photo 3 of 3 : UCIP\_SP\_2019\_52751\_24536.jpg

Siphon breaker and 1.5-inch galvanized iron electrical conduit.

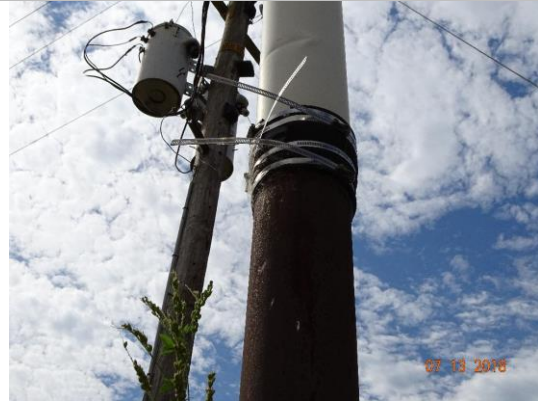
Photo 1 of 3 : UCIP\_SP\_2019\_52732\_77687.jpg

Leak at pipe join seems to be fixed with steel clamps.

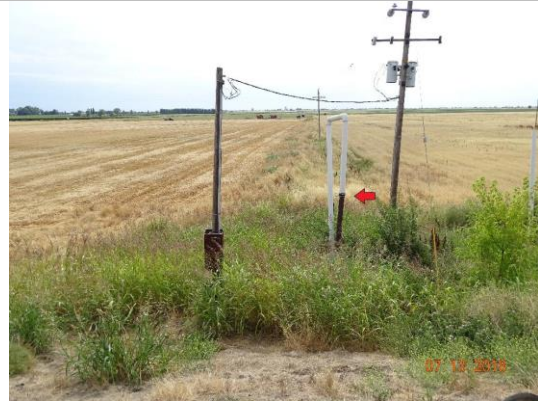
Photo 2 of 3 : UCIP\_SP\_2019\_52732\_77689.jpg

View of standpipe with dense vegetation around.

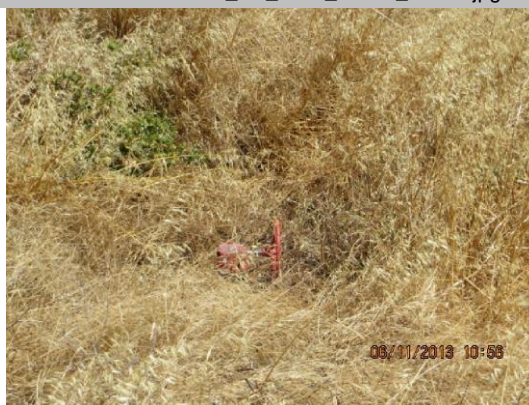
Photo 1 of 3 : UCIP\_SP\_2019\_52753\_24545.jpg

Butterfly valve on LS toe.

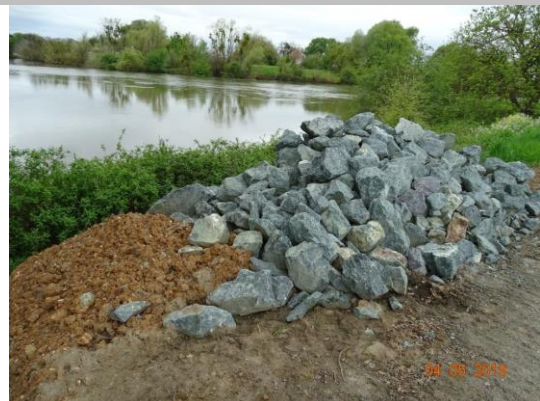
Photo 1 of 1 : SP\_2019\_RD0563\_210\_154\_20190405\_00232.jpg

View of rock placed by LMA on waterside shoulder (Spring 2019).

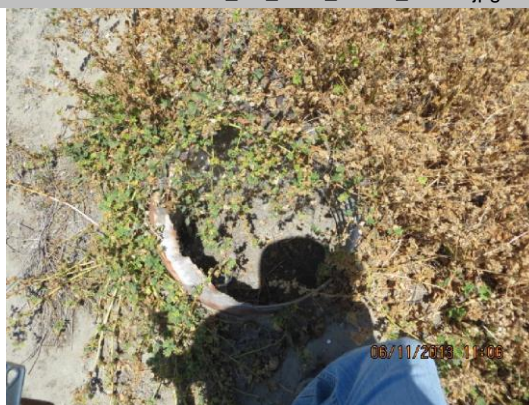
Photo 1 of 3 : UCIP\_SP\_2019\_52754\_24548.jpg

24-inch CMP standpipe on LS slope.

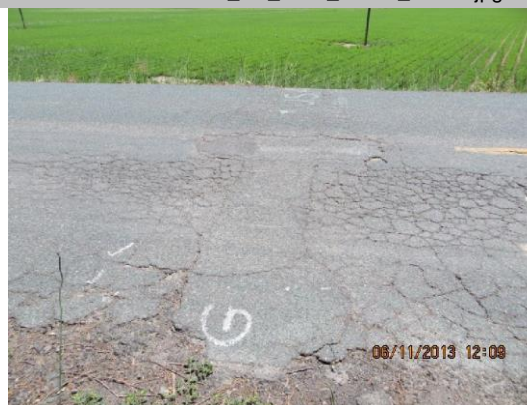
Photo 1 of 3 : UCIP\_SP\_2019\_52758\_27390.jpg

Cut in pavement with USAA markings for gasoline.

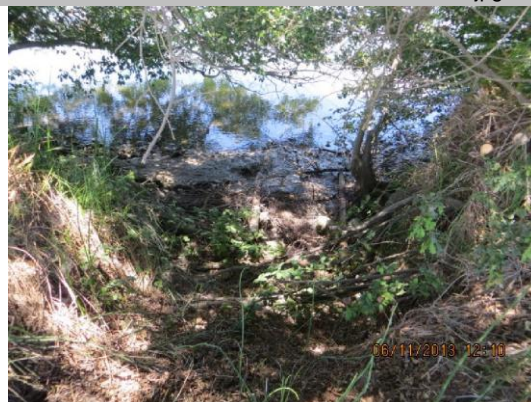
Photo 3 of 3 : UCIP\_SP\_2019\_52758\_27388.jpg

Pipe visible on WS toe.

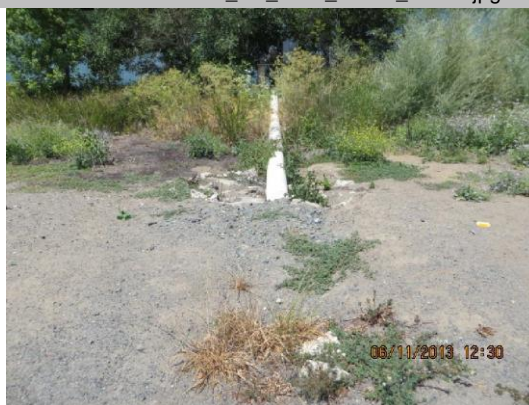
Photo 2 of 3 : UCIP\_SP\_2019\_52761\_24589.jpg

Pipe on WS slope.

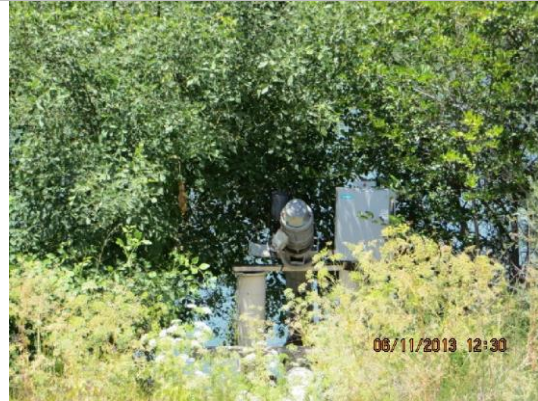
Photo 3 of 3 : UCIP\_SP\_2019\_52761\_24588.jpg

Slant pump off WS toe.

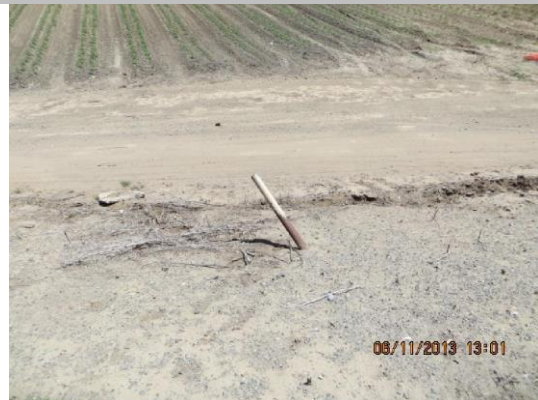
Photo 1 of 2 : UCIP\_SP\_2019\_16289\_27439.jpg

Pipe visible on LS slope.

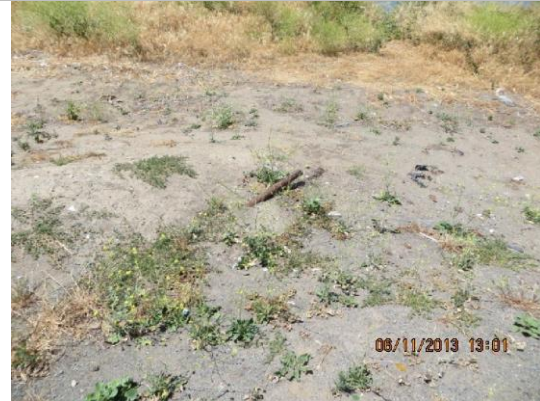
Photo 2 of 2 : UCIP\_SP\_2019\_16289\_27438.jpg

Pipe visible on WS shoulder.

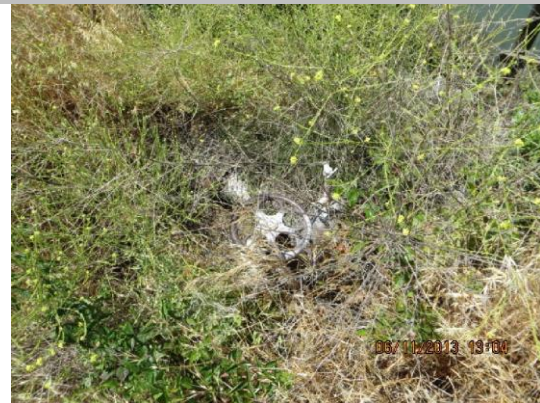
Photo 1 of 3 : UCIP\_SP\_2019\_14949\_24603.jpg

Slide gate at pump on WS slope

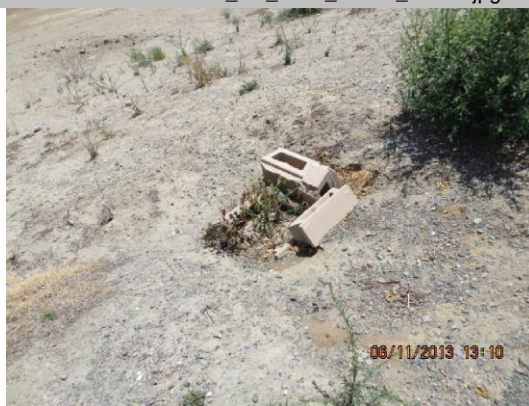
Photo 1 of 3 : UCIP\_SP\_2019\_14950\_24607.jpg

Vent/filler pipe exposed on LS shoulder.

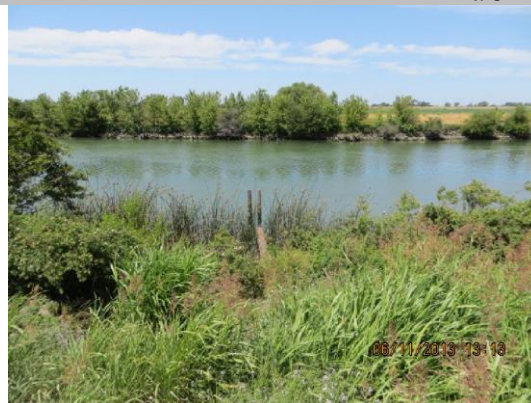
Photo 3 of 3 : UCIP\_SP\_2019\_14950\_24605.jpg

Pipe visible on WS toe.

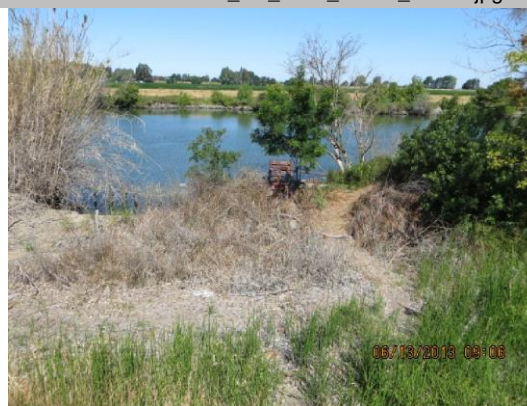
Photo 3 of 3 : UCIP\_SP\_2019\_40790\_24631.jpg

Steel walkway support for pipe on WS toe.

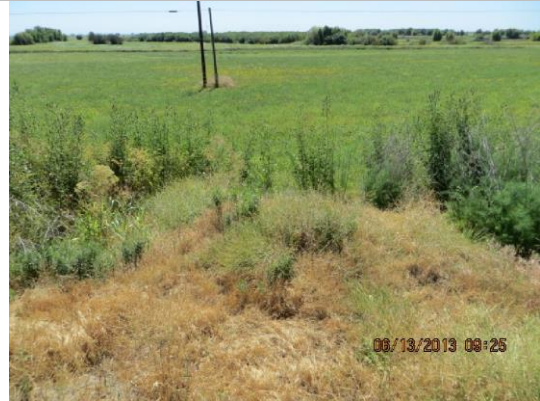
Photo 3 of 3 : UCIP\_SP\_2019\_14968\_24635.jpg

Wide berm on LS toe.

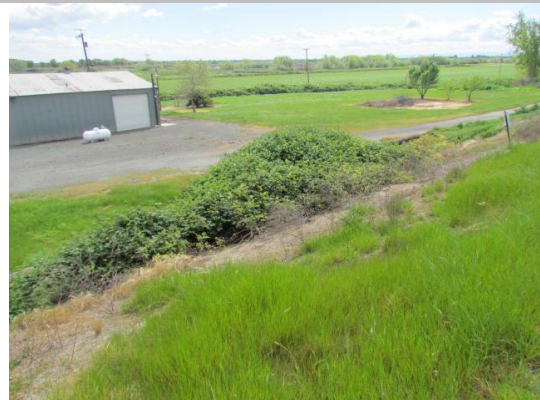
Photo 1 of 1 : SP\_2019\_RD0563\_210\_151\_20190311\_00112.jpg

Looking southeast at dense vegetation at landward toe.

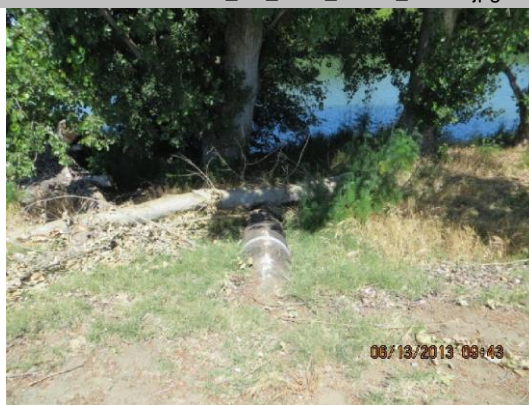
Photo 1 of 2 : UCIP\_SP\_2019\_42743\_24641.jpg

Pipe visible on WS slope.

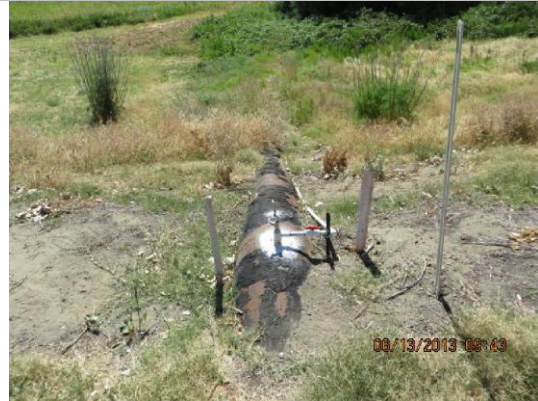
Photo 2 of 2 : UCIP\_SP\_2019\_42743\_24640.jpg

Pipe, vent, and filler valve on LS shoulder.

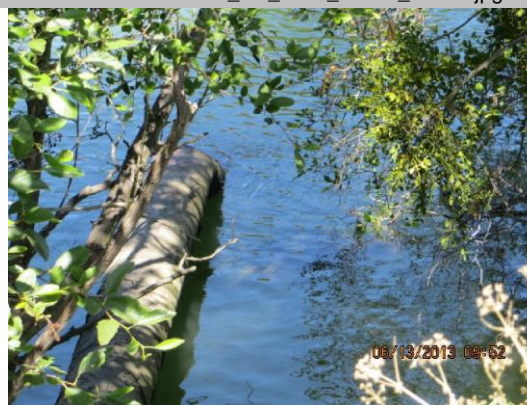
Photo 2 of 2 : UCIP\_SP\_2019\_16304\_27463.jpg

Pipe visible on WS toe.

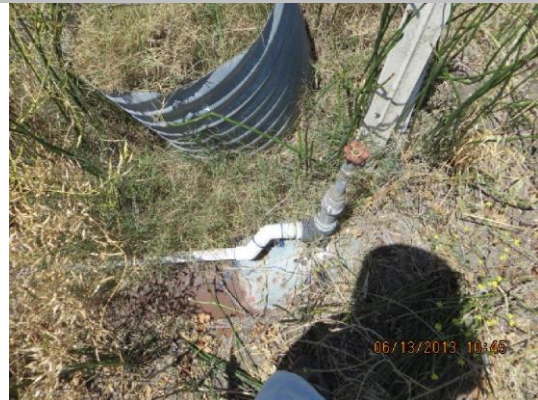
Photo 1 of 3 : UCIP\_SP\_2019\_14988\_24670.jpg

air vent/filler pipe on LS shoulder.

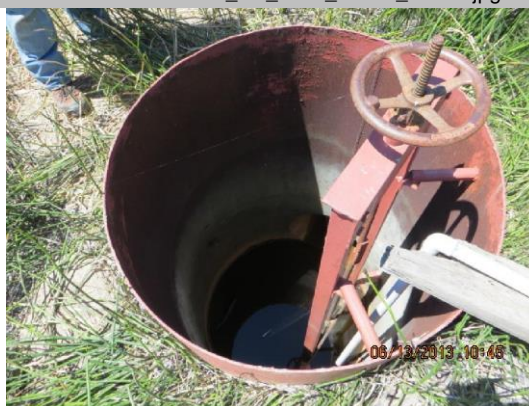
Photo 2 of 3 : UCIP\_SP\_2019\_14988\_24669.jpg

Slide gate in steel riser on LS toe.

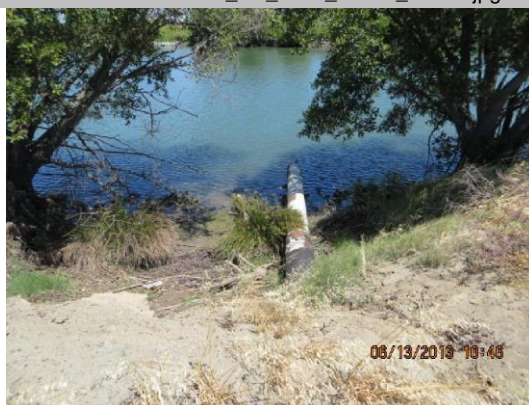
Photo 3 of 3 : UCIP\_SP\_2019\_14988\_24668.jpg

Pipe visible on WS toe.

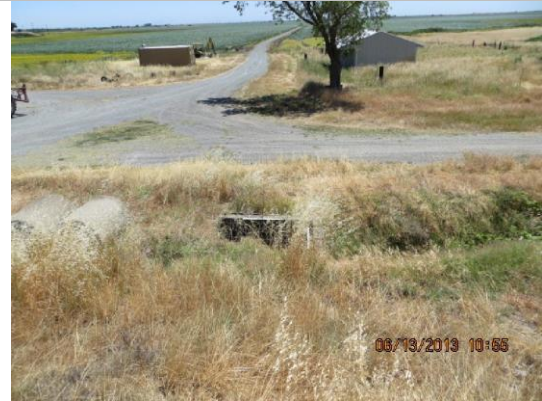
Photo 3 of 3 : UCIP\_SP\_2019\_14990\_24675.jpg

7'X9' concrete distribution box on LS toe.

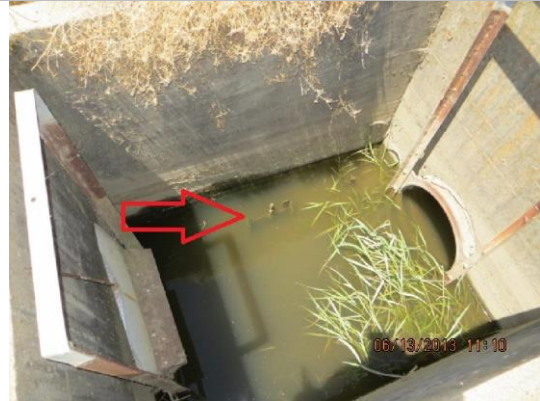
Photo 3 of 3 : UCIP\_SP\_2019\_16292\_27451.jpg

Broken slide gate in 7'X9' concrete distribution box on LS toe.

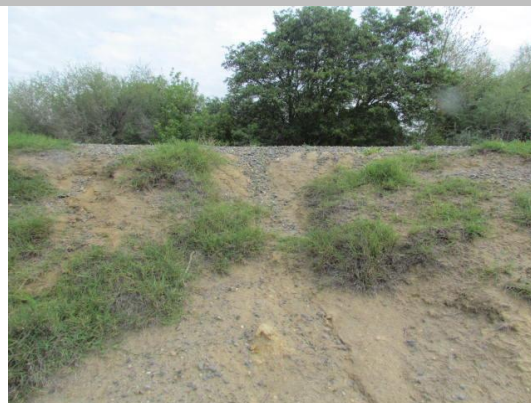
Photo 1 of 2 : SP\_2019\_RD0563\_210\_99\_20190311\_00069.jpg

Looking west at minor erosion on landward shoulder and slope.

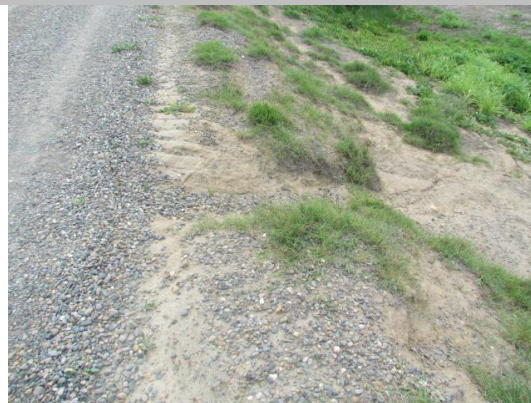
Photo 2 of 2 : SP\_2019\_RD0563\_210\_99\_20190311\_00070.jpg

Looking north at minor erosion on landward shoulder and slope.

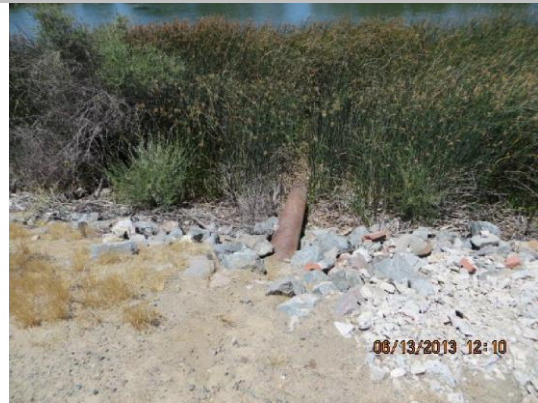
Photo 1 of 3 : UCIP\_SP\_2019\_52766\_24688.jpg

Pipe visible on WS slope.

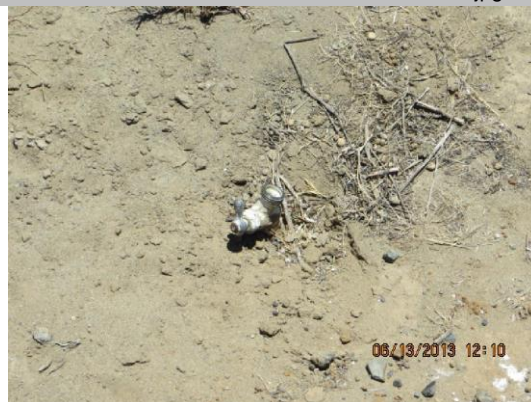
Photo 3 of 3 : UCIP\_SP\_2019\_52766\_24686.jpg

Vent/filler pipe on LS shoulder.

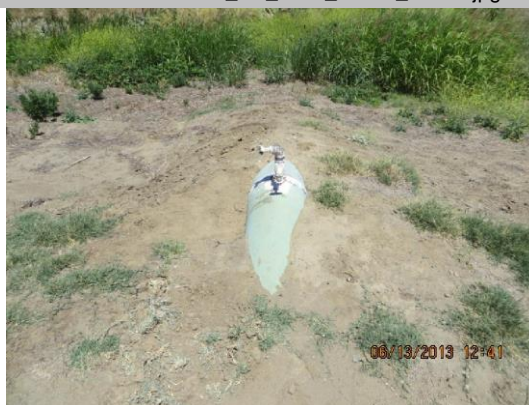
Photo 1 of 3 : UCIP\_SP\_2019\_52767\_24691.jpg

Vent/filler on pipe at LS shoulder.

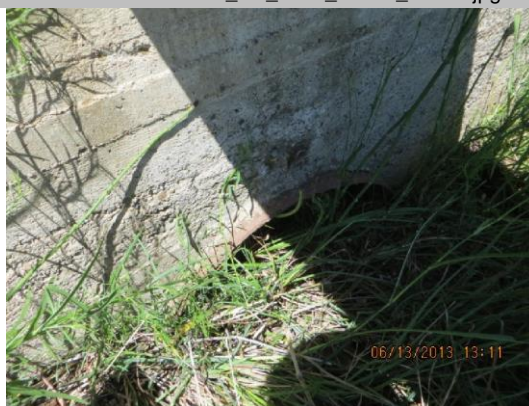
Photo 1 of 2 : UCIP\_SP\_2019\_15028\_24736.jpg

Pipe at concrete headwall on WS slope.

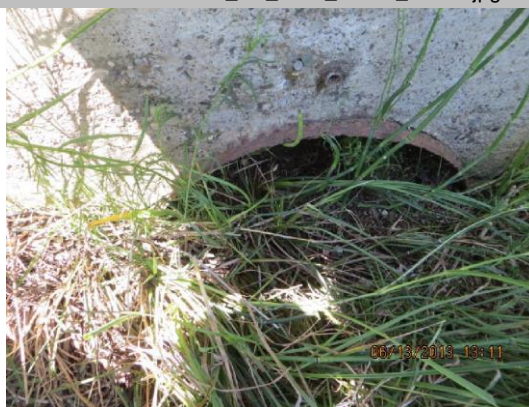
Photo 2 of 2 : UCIP\_SP\_2019\_15028\_24735.jpg

Pipe at concrete headwall on WS slope.

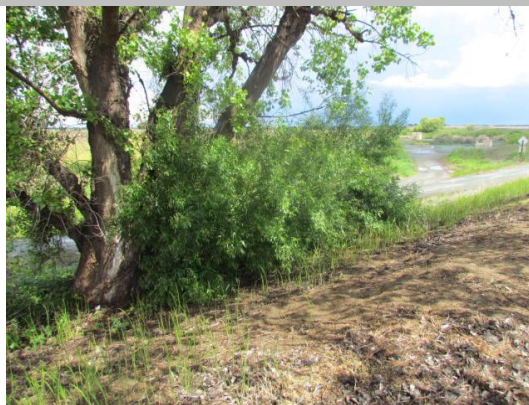
Photo 2 of 2 : SP\_2019\_RD0563\_210\_47\_20190311\_00019.jpg

Looking northeast at untrimmed tree at landward slope. (Spring 2015)
